<p>CONSTGLASS</p>  
<p>Table of results</p>

<p>Pilot object:</p>	<p><i>The death and assumption of the Virgin</i>, CHARTRES Bay 42, panel 22</p>	
<p>Pictures</p>

Sample reference:	<i>CHA_b42p22_I_v1: beige glass with Viacryl® consolidation on internal surface, silicone bonding and back plating</i>
-------------------	--

Sample reference: *CHA_b42p22_I_v3: yellow glass with Viacryl® consolidation on internal surface*

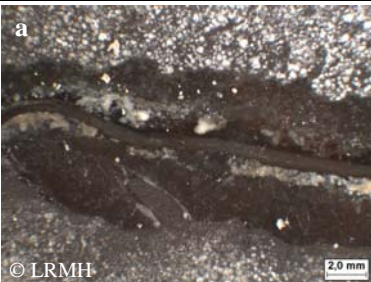
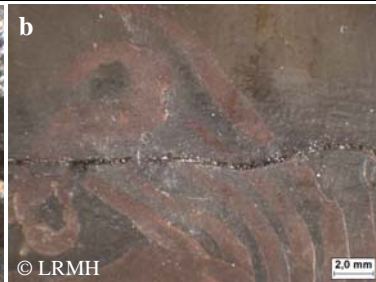
© LRMH 2.0 mm Detail of the silicone bonding, external (a) and internal (b) surface. No visible deterioration: it is still smooth, has a good adherence with the edges of glass.

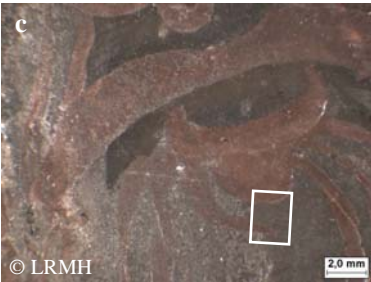
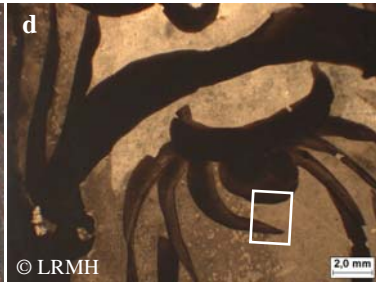
© LRMH 2.0 mm Internal surface in reflected (c) and transmitted (d) light. Glass paint is a little brilliant, it seems to have a good adherence with the support. Are the darker areas on glass due to Viacryl®? Or is it distemper? (White rectangle locates the SEM view).
	SEM

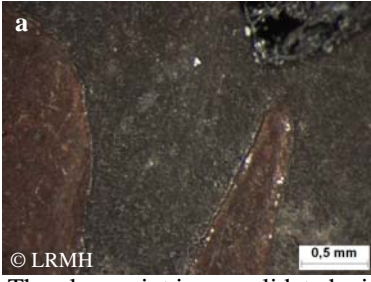
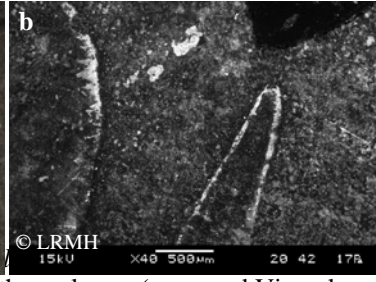
© LRMH 15kV X40 500mm 20 42 17s The glass paint is consolidated with a polymer (supposed Viacryl, V) which is also on the glass. But we can see glass paint without Viacryl® (arrows) on the edges of the lines. (black area on the top right corner is a carbon marker). So, Viacryl® seems to penetrate only the surface of the grisaille.

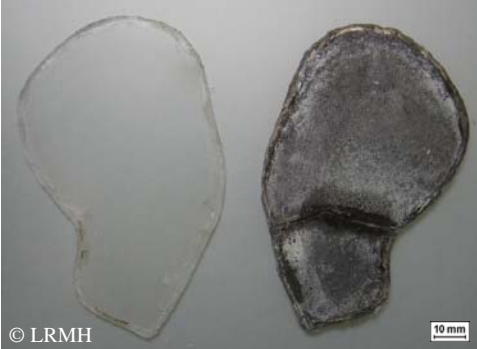
<p>© LRMH</p> <p>No dust or soot is observed on the internal side of the recent glass, due to a good hermetic bonding.</p> <p>The results on silicone bonding and back plating are the following:</p> <ul style="list-style-type: none"> • slight accumulation of dust and dirt: no visible fungal infestation; • metabolic activity: not undertaken in this case; • isolated microorganisms: none.
Reversibility	Test studies Elimination	Mechanical reversibility of the silicone rubber between back plating and ancient glass is easy: after opening the system with high precautions (with a scalpel), tearing off the joint and scouring with a rubber. Concerning glass paint, nothing was attempted regarding to its good state of conservation. <i>See tests performed on bay 37.</i>

Re-treatability	Test studies Re-treatability	No test on re-treatment was attempted, but a new transparent silicone without acetic acid (Silirub N05 neutral, Soudal) was used before the stop in of the back plating. No need to re-treat grisaille on this case. <i>See tests performed on bay 37, panel 16.</i>

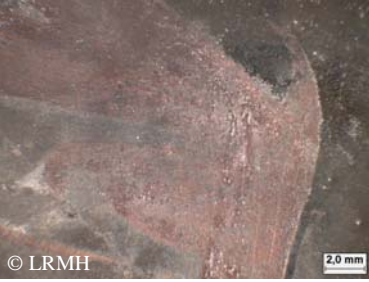
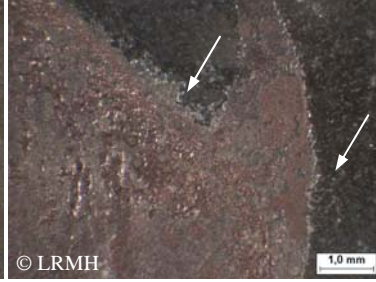
© LRMH 1,0 mm <i>a - detail of the grisaille before and after cleaning with a cotton saturated of water. The Viacryl® consolidant is visible on the cleaned area (brilliant aspect).</i> <i>b - detail of the grisaille after cleaning. Viacryl® seems to be still effective on the paint. The excess of Viacryl® is easy to see on the edge of grisaille (arrows).</i>
	SEM	<i>Not foreseen in this case: sample hasn't been unstopped.</i>
	Desktop tomography	<i>Not foreseen in this case: samples too large for tomography system.</i>
	Phase-contrast tomography on Synchrotron	<i>Not foreseen in this case: samples too large for tomography system.</i>
Chemical Composition	SEM/EDX	<i>Not foreseen in this case: sample hasn't been unstopped.</i>
