CONSTGLASS

Table of results

The *Crowning Virgin and the 12 apostles*, LE MANS  
Bay XVI, panel 6

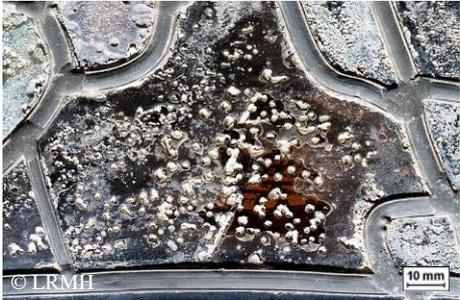
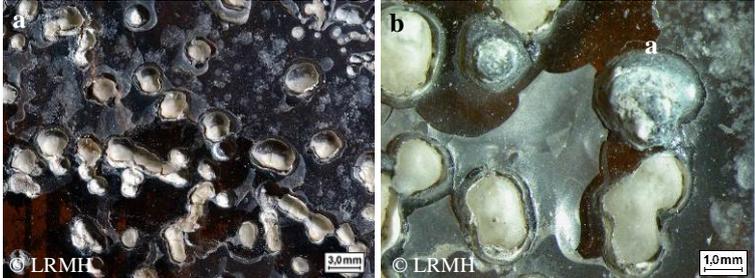
<p><b>Optical Microscope</b></p>	<p>On most of the pieces, Viacryl® has been washed away by rain and wind. Here, a large part is still on the glass, with different states of degradation. On healthy glass, Viacryl® has a good adherence with a development of bubbles (a-). On the edges of craters, the coating is cracked and there is a complete loss of adherence on the glass around (b-).</p>

<p>a - areas with and without Viacryl®.</p> <p>b - rests of Viacryl® around craters.</p>
	<p><b>SEM</b></p>

<b>Reversibility</b>	<b>Test studies Elimination</b>	<p>Tests have been made with water-ethanol poultice during 30 minutes. The rests of coating are soften and then could be removed carefully without taking off the gel layer. Several applications are possible if necessary.</p> <p>The restoration has been made in 2005 by Alliou studio (Le Mans, 72) and Pivet studios (Morthemer, 86), in accordance with the LRMH recommendations.</p>
<b>Re-treatability</b>	<b>Test studies Re-treatability</b>	<p>No re-treatability was recommended. An external protective glazing was installed in 2008, by Debitus studio (Tours, 37).</p>

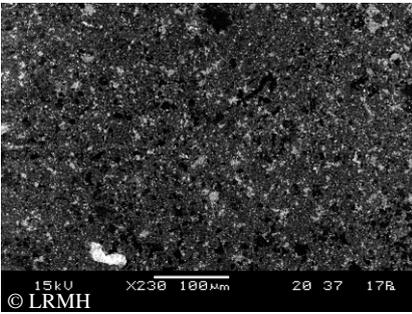
<p>The SEM observations and analyses show that Viacryl® tore off a thin gel layer and a little amount of gypsum.</p>
	<p><b>Desktop tomography</b></p>	<p><i>Not foreseen in this case</i></p>

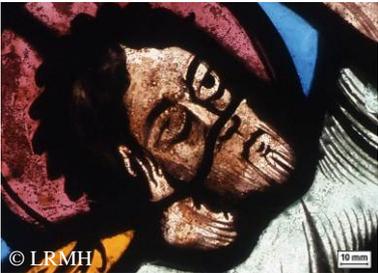
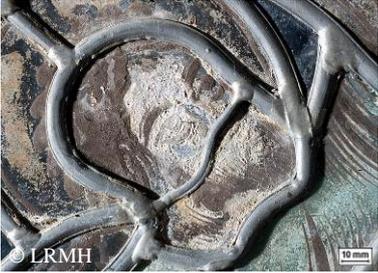
<p>© LRMH 10 mm</p> <p><i>Reflected light</i></p>	<p><b>Optical Microscope</b></p> <p><b>SEM</b></p> <p><b>Desktop tomography</b></p>	<p>Most of the grisaille has a good shape on the glass. But on some areas, corrosion products are emerging on the glass and the paint. In most of the cases, this phenomenon does not take off the grisaille from its support. The corrosion products on the glass seem to peel: is it Viacryl® pushed away by alteration?</p>

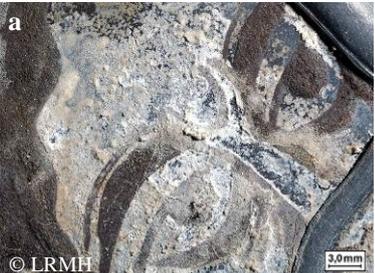
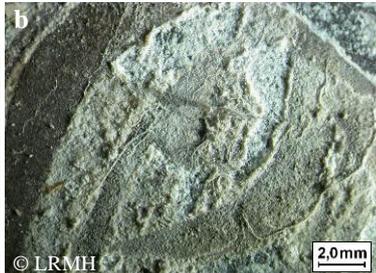
<p>© LRMH 2.0mm</p> <p>a - corrosion products on glass and paint, proliferating preferentially on glass.</p> <p>b - detail of the eye: corrosion on the paint without big damage to the paint (no delamination).</p> <p>Corrosion products have been sampled on the glass.</p> <p>The gel layer (G) has been torn off with corrosion products (C). On this sample, Viacryl® is not seen.</p>

<b>Phase-contrast tomography on Synchrotron</b>	<i>Not foreseen in this case</i>
<p><b>Chemical Composition</b></p> <ul style="list-style-type: none"> <li>- What is the chemical composition of the alteration products?</li> </ul>	<b>SEM/EDX</b>	<p>The gel layer is a stratum of glass depleted in alkali and alkaline earth metal.</p> <p>The main component of corrosion products is gypsum. It comes from alteration of the glass or alteration of rests of putty.</p>
<p><b>Organic component composition</b></p>	<b>FTIR</b> <b>RAMAN</b>	<i>Not foreseen in this case, see panel 10</i>
<p><b>Microbiology</b></p>	<b>Molecular biology, ATP measurements</b>	<i>See sample "microbiology tests" at the end of this data sheet.</i>
<p><b>Reversibility</b></p>	<b>Test studies Elimination</b>	<p>The restoration has been made in 2005 by Pivet (Morthemer, 86) studio. N-methyl-2-pyrrolidone has been used to remove Viacryl® and corrosion products.</p>
