CONSTGLASS

Table of results

Ref. Parish Church south – Panel of fragments

Doubling red flashed glass with Araldite®.

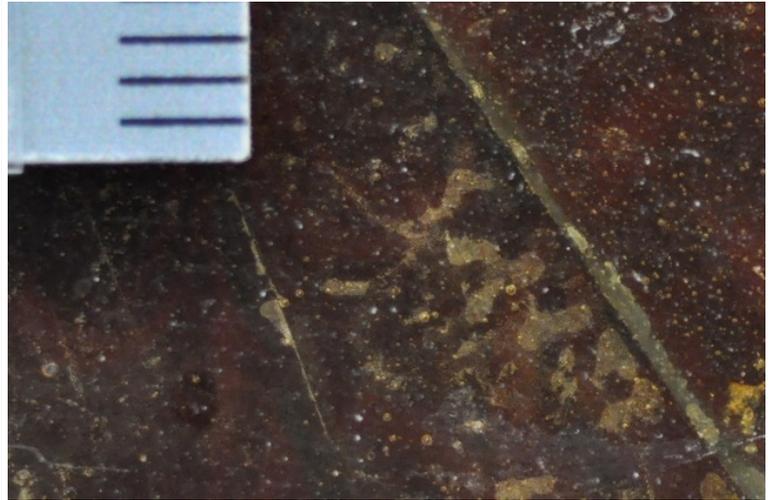
Stage 3:

Clear and transparent resin filling, beginning of or advanced yellowing. The plated glass compound has still a dark shining aspect. The whitish “micro-bubbling” is getting denser. Due to the yellowing of the material, the bubbles can have a brown-ochre colour, under reflected light the areas can also look “milky”. The adhesion starts to weaken in these parts, but in general it is still very strong.

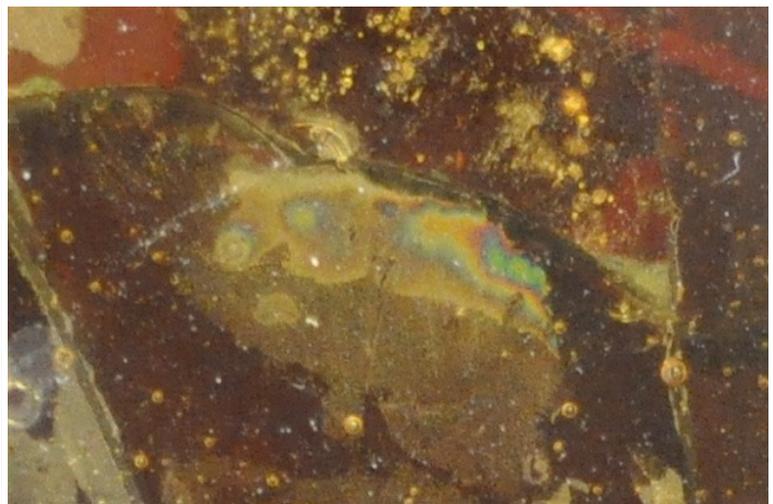
Stage 4:

Changing aspect from bright, white, shiny aggregations of points to iridescent surface areas. The Araldite® surface does not look “deep dark” any more, but rather white on dark (mostly to be seen on edgings or cracks, where mechanical impacts and movements may have occurred).

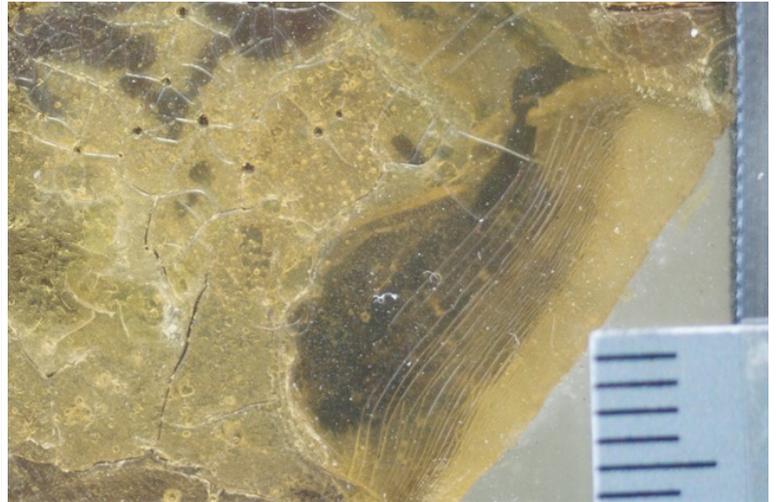
Stage 7:

The Araldite® looks golden, amber until ochre-yellow. The layer begins to break up, by lined-up cracks or flakes. It seems that at this step it has been detached from both glass surfaces.

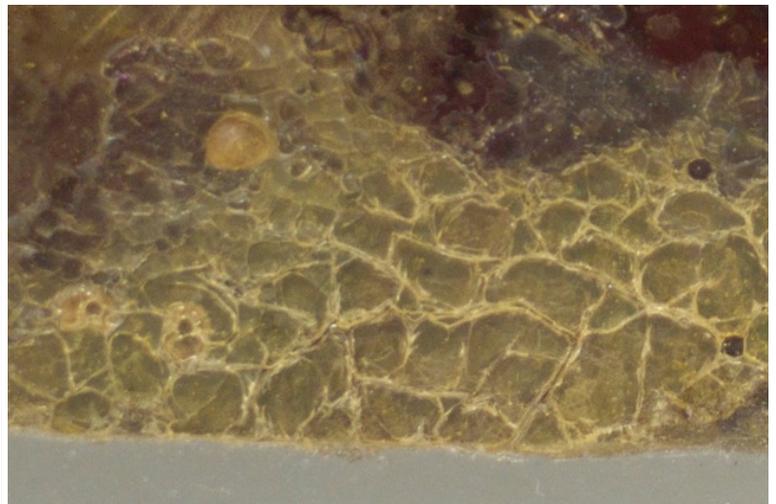
Stage 8:

Yellowed Araldite® with a shining whitish surface aspect looks therefore as detached from both surfaces. Broken up by cracks or flakes, also shrunken “flake-insulate” which can even overlap.

(Air bubble from process.)

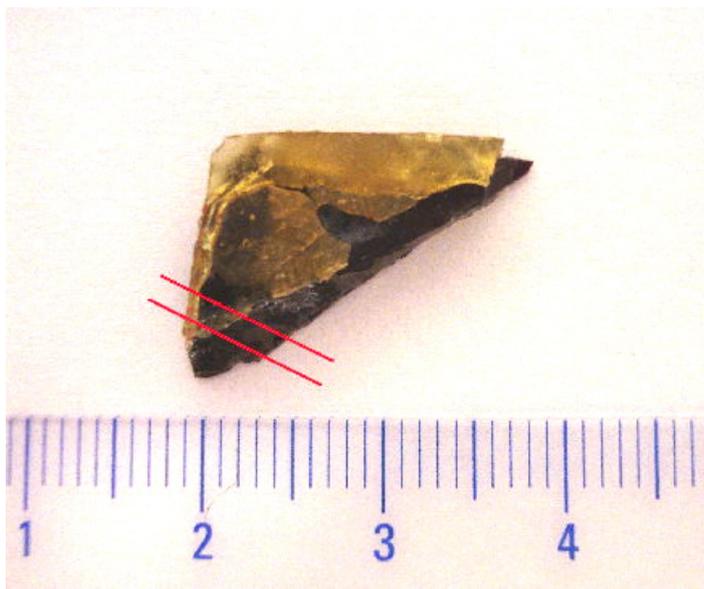
Sample CSRIV_01

The sample has been analysed with phase-contrast micro tomography, with photon energy of 27 keV and a sample-to-detector distance of 66 cm, in order to enhance the contribution of the low-absorption consolidant.

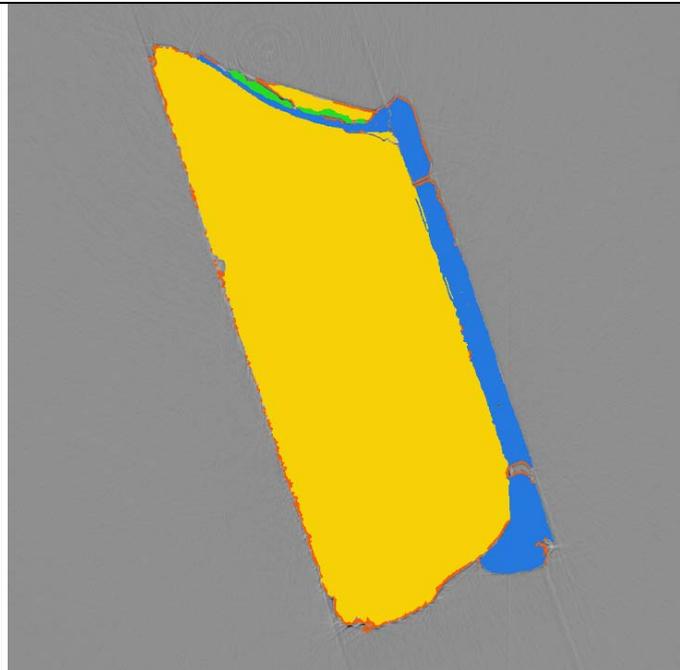
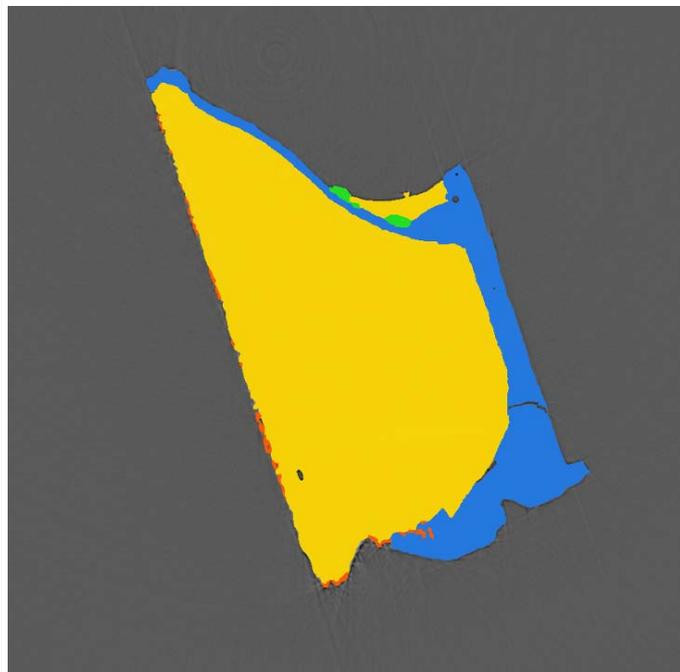
The two images are related to two different positions on the bottom tip from the sample photo on page two of the data sheet.

- the original glass is yellow
- the Araldite® is pale blue
- the metal parts are red
- the degraded glass is green

<p>With the exception of the edges of the fragments, the Araldite[®] sticks rather well to the glass, even if there are some cracks from the surface to the glass. The green parts could be, in principle, either Araldite[®] or glass, but the second hypothesis is more correct. The small metal parts can come both: from the grisaille or, in general, from some pigments, but sometimes come from the lead frames.</p> <p>The situation is pretty much the same both for the opaque and the transparent Araldite[®] forms, and the loss of adhesion is usually confined to the edges of the fragment, even on the other tip of the glass segment.</p> <p>Particular observations: The plating glass has been detached; its surface seems to have been smoother than the surface of the original.</p> <p>The crack in the epoxy layer occurs at the border between parts of different thickness. This confirms an observation on larger samples: The effect could be due to shrinking, but also to the different mechanical stresses due to thermal expansion (glasses, but especially the resin itself).</p> <p>In the crack area (top of the image, old crack reopened for sampling), the well adhering epoxy infill has stripped off a part of the adjacent glass – evidence for the risks of de-restoration.</p>

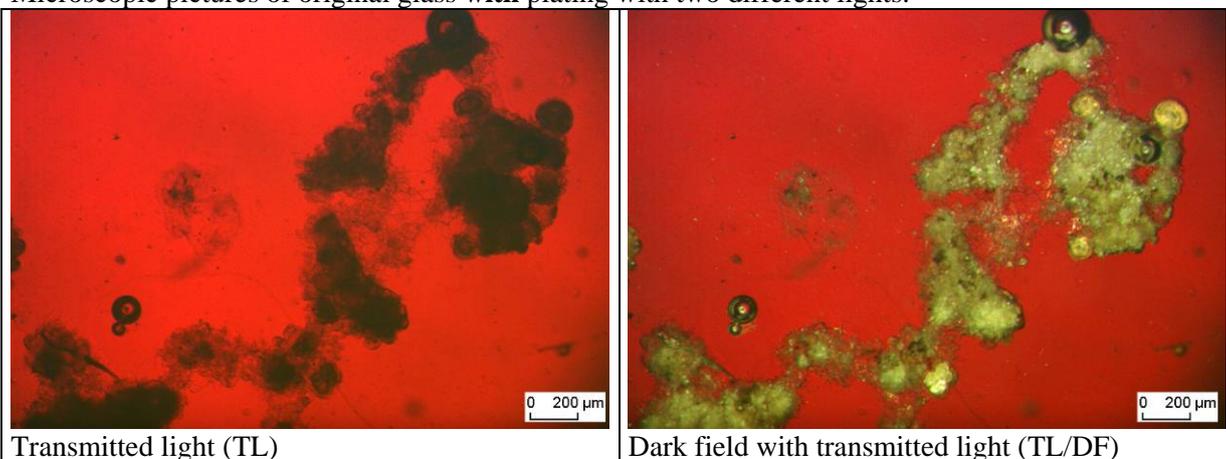
Microscopic pictures of original glass **with** plating with two different lights.

Corrosion phenomena, which can be found under the yellow aged Araldite® plating, looking yellowed discoloured, depending on the light. Without plating these phenomena looks grey-whitish. The original glass shows often this damage.

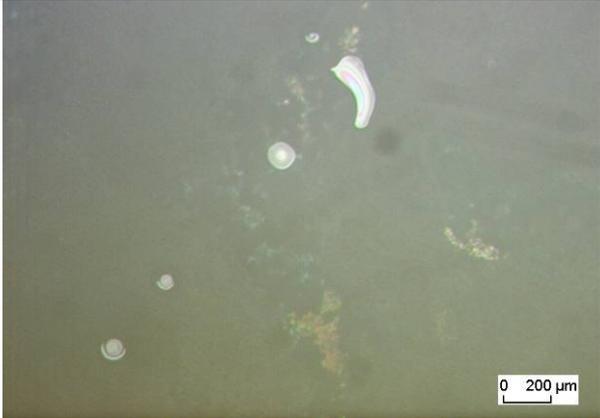
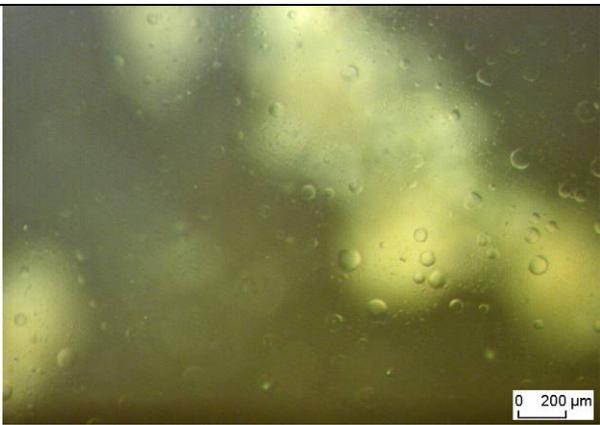
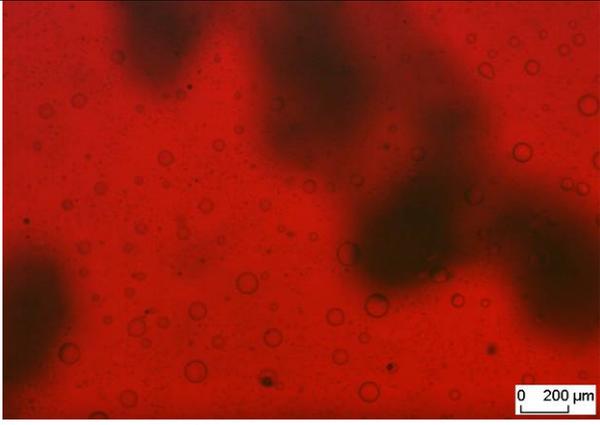
Stage 3

- Cover glass-Araldite®: Good connection between cover glass and Araldite®. Araldite® shows yellowing and conditional of manufacturing bubbling (RL/DF and TL/DF), locally small iridescent areas (RL).
- Araldite®-original glass: no abnormalities visible

<p>RL</p>	<p>No abnormalities</p>

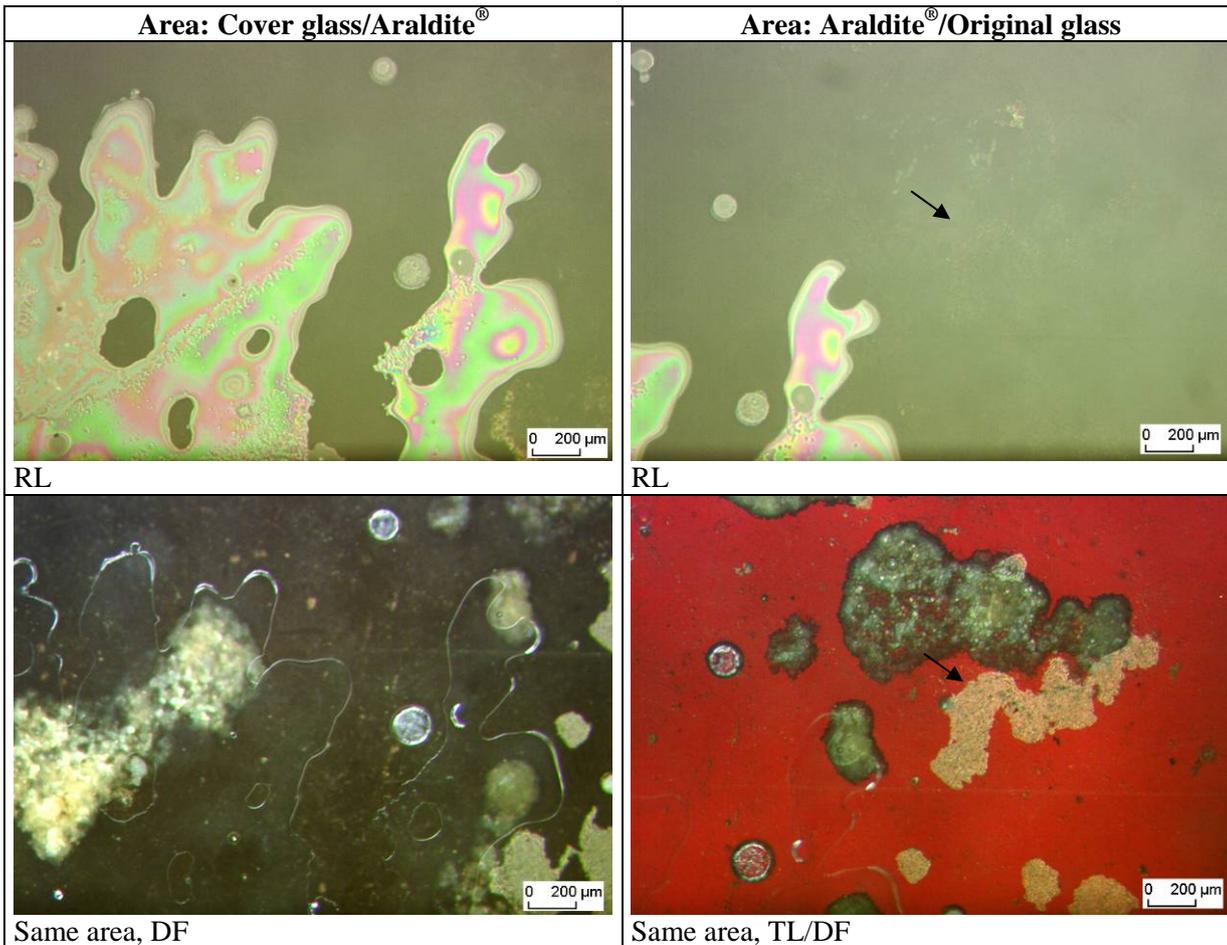
Stage 4

- Cover glass-Araldite®: Connection between cover glass and Araldite® is partially broken. The new very thin gap between both media looks iridescent (RL) or milky (TL/DF), because of light optic phenomena.
- Araldite®-original glass: Connection between Araldite® and original glasses is in smaller areas broken. The Araldite® looks whitish crystalline; the phenomena are only visible in dark field.

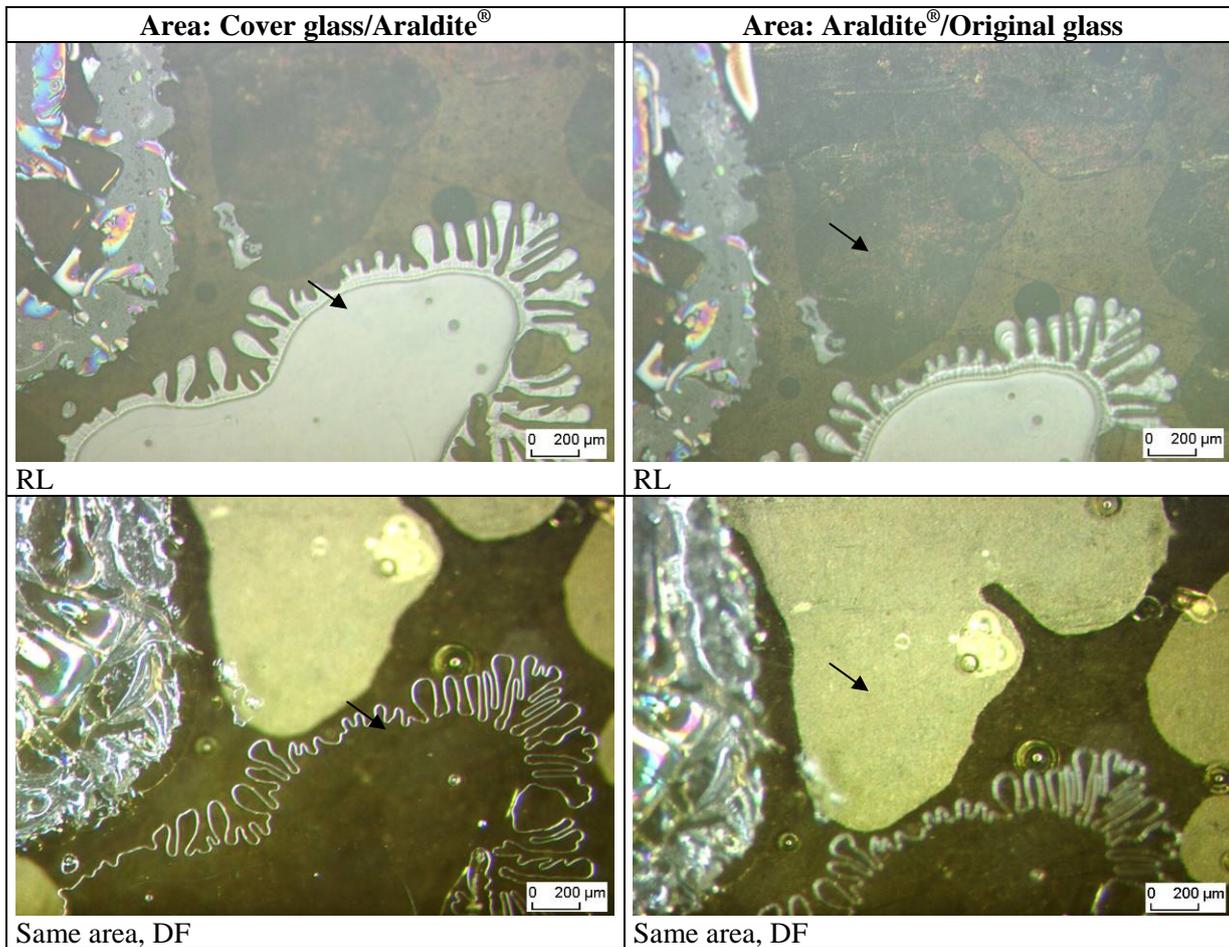
Stage 5:

- Cover glass-Araldite®: Proceeding of gap formation between cover glass and Araldite®. Iridescent decrease because of the increasing of gap width. Grey-blue emerging damage phenomena (RL). In dark field only the border line are visible, on other areas it is transparent (DF).
- Araldite®/Original glass: Araldite® is dissolving in bigger areas, but not laminar, from the original glass. Increasing of the whitish crystalline areas – mainly visible in dark field. In reflected light as dark and partly iridescent areas weakly visible.

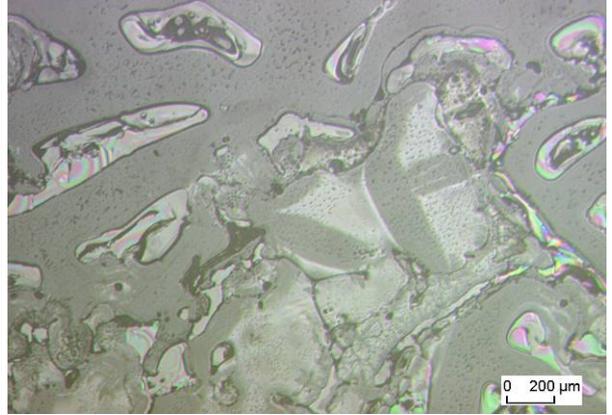
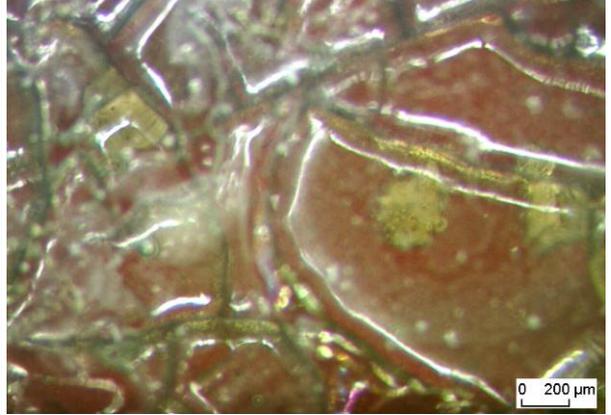
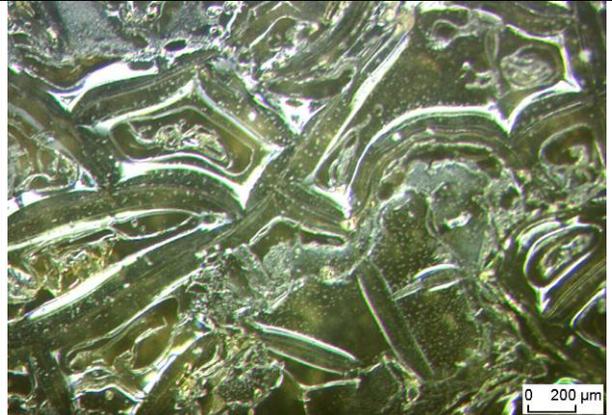
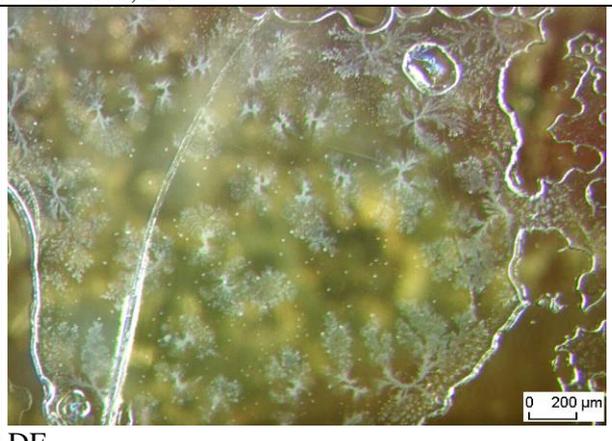
Stage 6:

- Cover glass/Araldite®: The adhesion properties of the Araldite® have changed significantly: uneven appearance, formation of rough segments which adhere either at the cover or on the original glass (RL+DF). Maybe the appearance has changed because of the contraction respectively the expansion of the plating material. On the inner side of the cover glass partly crystalline structures are visible (DF).
- Araldite®/Original glass: Araldite® adheres mainly on the original glass. Only isolated smaller golden yellow areas visible. These could be a hint for the beginning of delamination (image presentation is difficult).

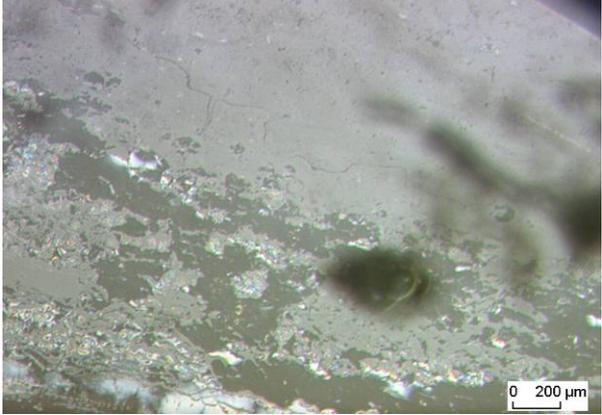
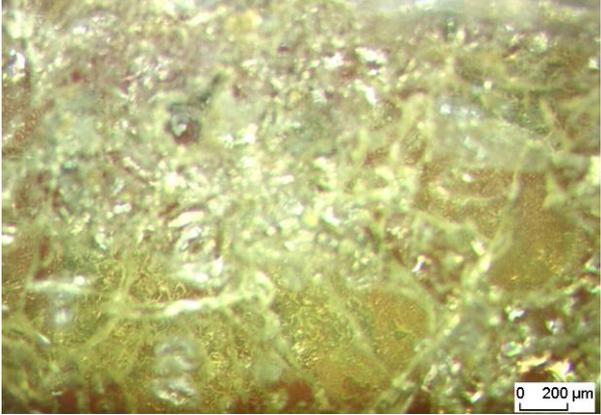
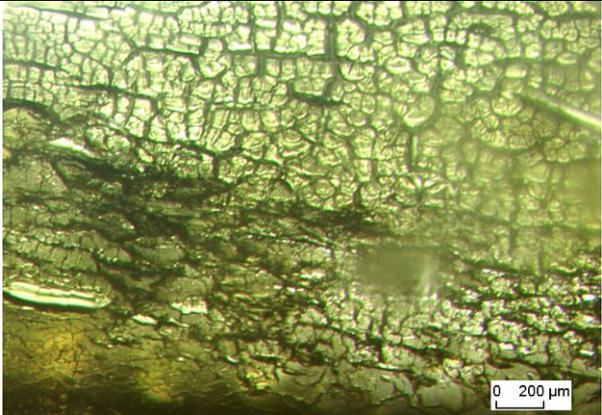
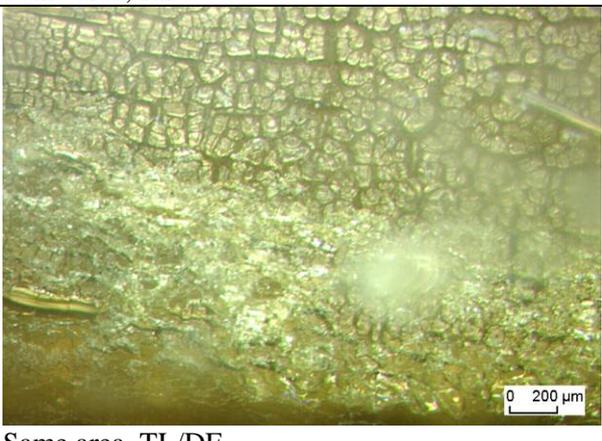
Stage 7:

- Cover glass/Araldite®: The damage phenomena of stage 6 are increasing and the segmentation gets finer. The connection between Araldite® and cover glass is only locally existent. This is good visible on the light-grey and large-scaled areas (RL).
- Araldite®/Original glass: The Araldite® appears golden yellow, large-scaled and crumbling. This damage is a hint for the increasing brittleness of the Araldite®. The connection of the Araldite® to the original glass was also decreased.

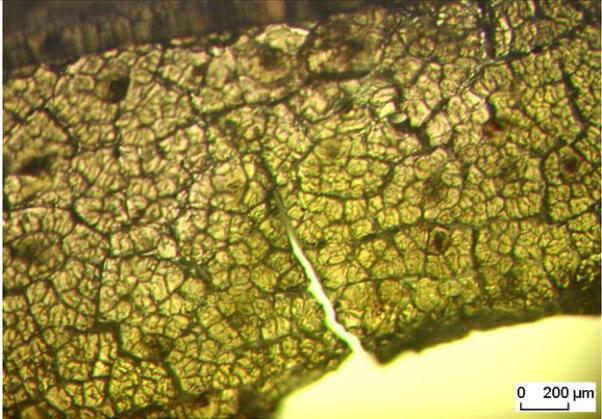
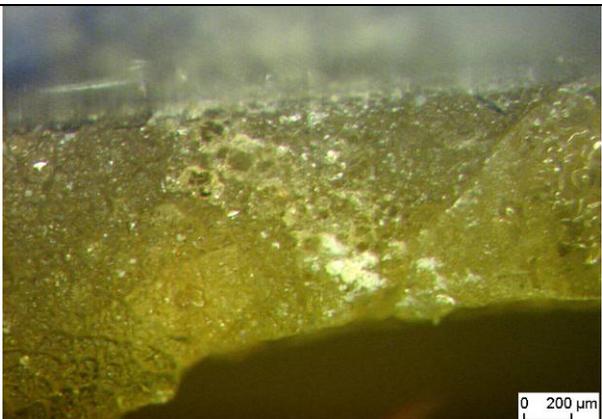
Stage 8:

- Cover glass/Araldite®: Connection between cover glass and Araldite® is totally lost. Brittleness of Araldite® leads to a fine segmentation and to a bigger crack structures and holes. Small whitish structures can partly be found on the Araldite® (DF).
- Araldite®/Original glass: Connection between Araldite® and original glass is totally lost. The demonstration of this corrosion phenomenon is only hardly possible with microscopic techniques.

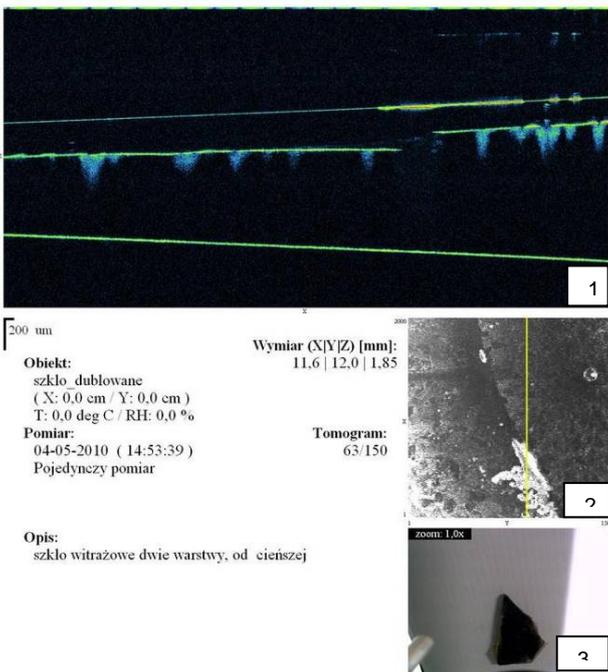
fig. 1. Typical OCT scan report of the sample of Romont glass

1. The final scan
2. The scanned area (yellow line depicts the scanning line)
3. The picture of the sample showing the spot of scanned area
4. The written information is the description of scanning conditions. The most important one is: **Wymiar (X,Y,Z) [mm]** with information on of dimensions of scanned area. In example below: X=11.6 mm; Y=12 mm and Z=1.85 mm. Z is the deep of light penetration. Bear in mind that the X value is on vertical axis and Y on horizontal one.

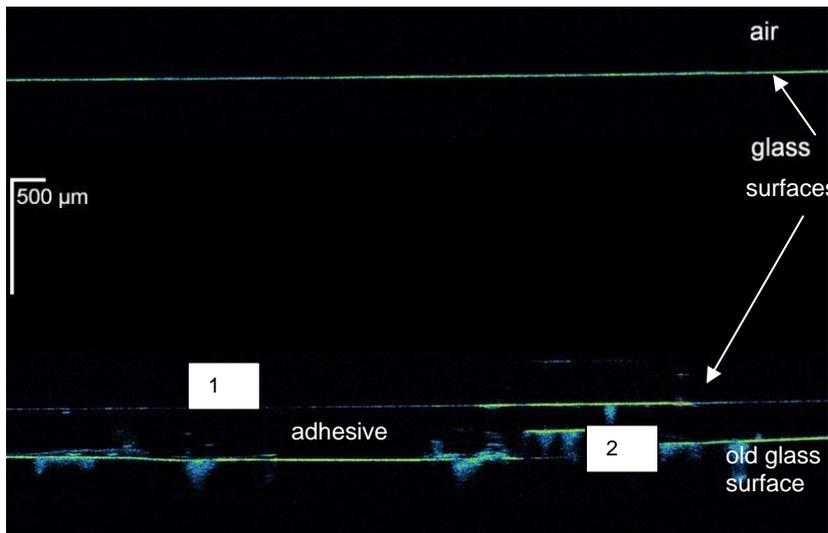
fig. 2 Scan of the Romont sample from the back

Fig 2 shows the OCT scan from the back of the sample, i.e. from the backing glass. The depth of penetration of IR radiation is about 2 mm (cf. the scale) and reaches through the glass and adhesive to the back surface of the old glass. The interface backing glass - adhesive gives only information that there is no delamination between them, but on the old glass surface several phenomena are seen: 1. corrosion 2. delamination of the glass surface which might have been caused by adhesive's contraction.

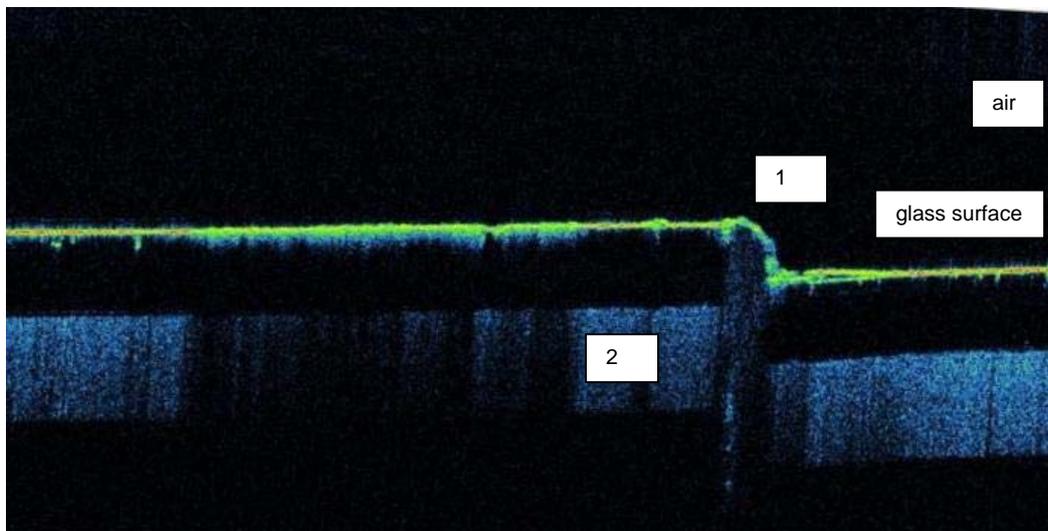
fig. 3. OCT scan from the face of the sample

The scan depicted on fig.3 shows a (1) glass breaks with slightly uneven joint of glass edges and (2) the copper flashed surface.
