<p>CONSTGLASS</p>  
<p>Table of results</p>

<p>Pilot object:</p>	<p><i>The death and assumption of the Virgin</i>, CHARTRES Bay 42, panel 22</p>	
<p>Pictures</p>

Sample reference:	<i>CHA_b42p22_I_v1: beige glass with Viacryl® consolidation on internal surface, silicone bonding and back plating</i>
-------------------	--

Sample reference: *CHA_b42p22_I_v3: yellow glass with Viacryl® consolidation on internal surface*

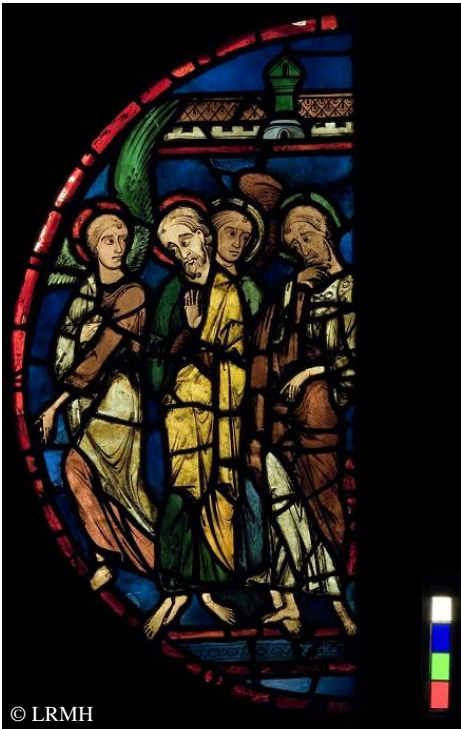
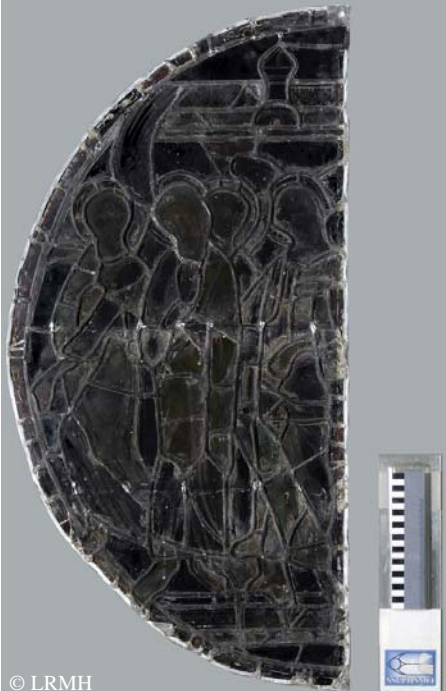
<p>© LRMH</p>	<p>Identification of the panel:</p> <p>Bay: 42 Panel: 22 Internal face, transmitted light Internal face, reflected light</p> <p>Treatment:</p> <ul style="list-style-type: none"> - 1988, by Alliou studio. - Products: polyurethane resin (80% Viacryl® SM564 + 20% Desmodur® N75), silicone CAF 3 and cold painting. - Application: with a soft brush after cleaning.

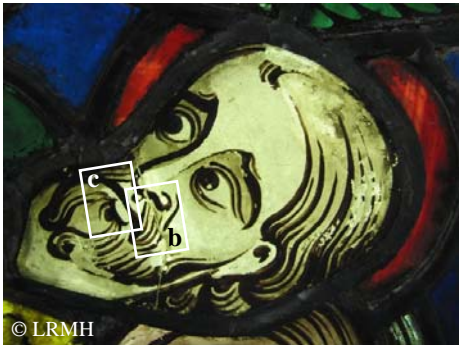
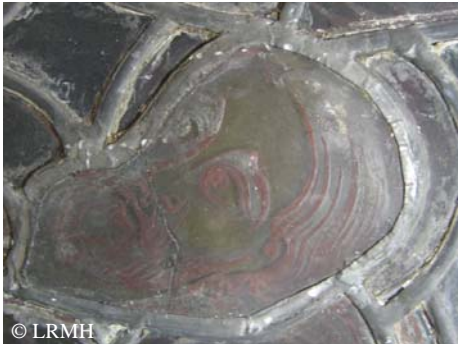
© LRMH White rectangles locate the optical microscope observations (b and c)	Optical Microscope

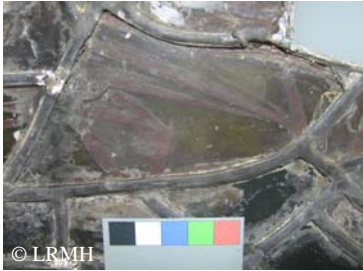
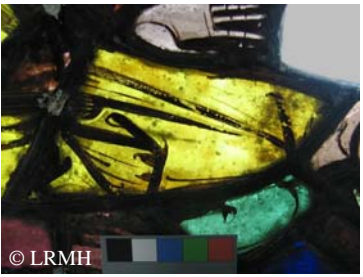
Conclusion: the consolidation is still effective on most of the paints of the panel. There is not much corrosion products, but a lot of putty which was not removed during last restoration. The corrosion of the latter is starting or resuming on some isolated areas. On some pieces, the healthy grisaille is taken off by a thin layer of deteriorated glass. The consolidation does not avoid this phenomenon.
