CONSTGLASS

Table of results

Ref. Parish Church south – Panel of fragments

Doubling red flashed glass with Araldite®.

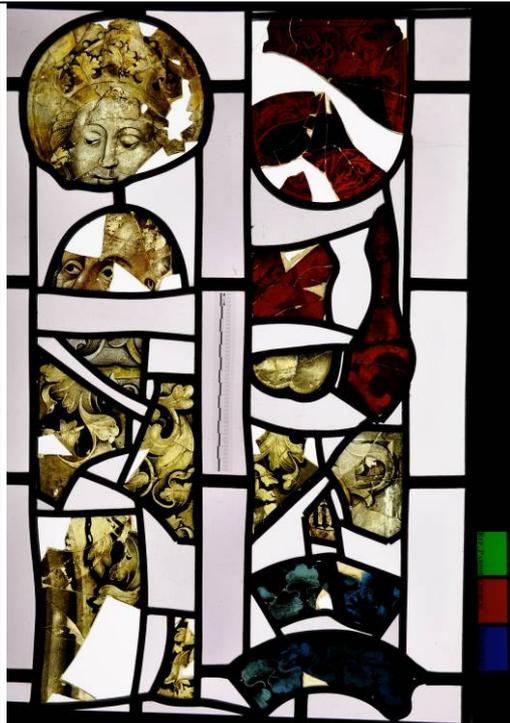
Internal face, transmitted light

External face, reflected light

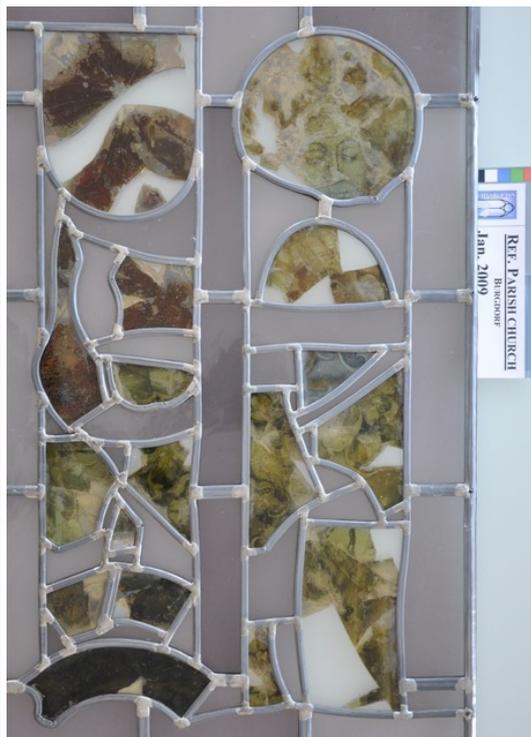
- 1971, by Konrad Vetter;
- Araldite® binder AY103 by 100 parts;
Hardener HY951 by 9 parts, (Astorit AG 8840
Einsiedeln);
- For thin fragments (1-1.5mm) with multiple fractures,
the simple edge bonding was not considered to be
sufficient and the method of back-plating was used.
